Rail Accident Report

Head-on collision between a passenger train and a freight train
in Tempi, 28 February 2023

RL01-2025, 27 February 2025

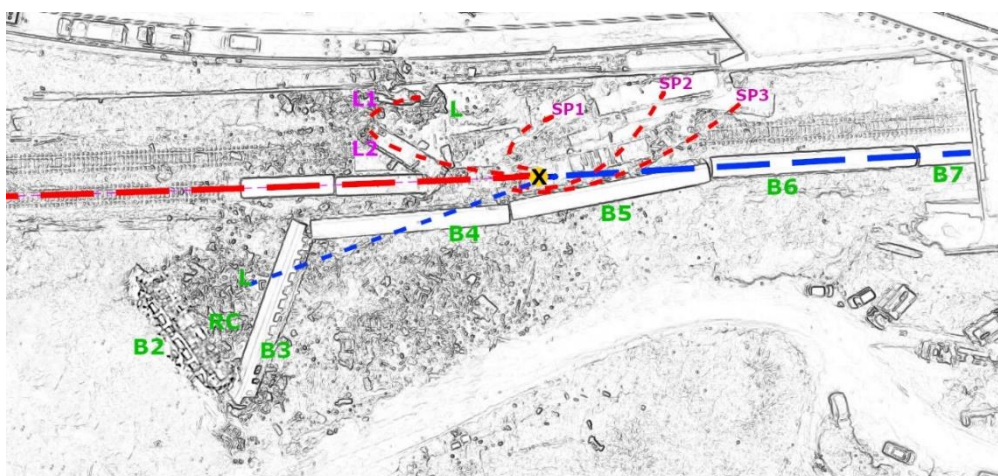
Figure 11. Global movement of the collision, with the initial impact and catapult effects. (SP1,2,3 are Steel Plates, and were also catapulted)

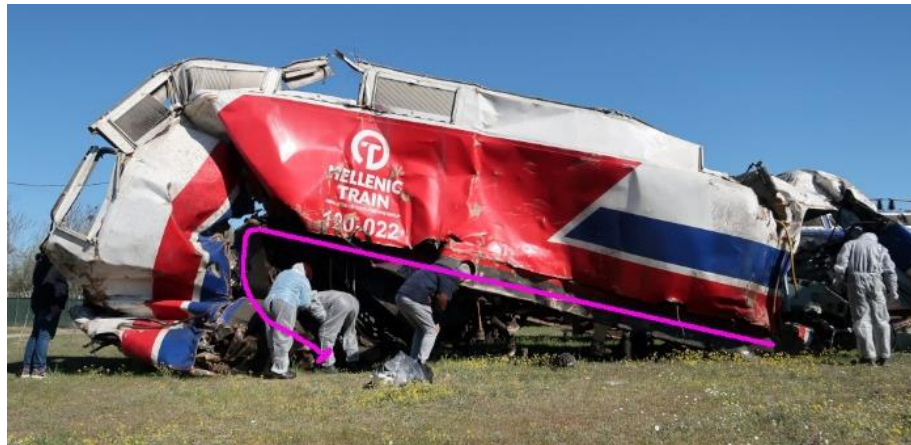
Figure 14. The first locomotive of the freight train (120-022) showing extreme damage from the very heavy head-on collision with the locomotive (120-023) of the passenger train.

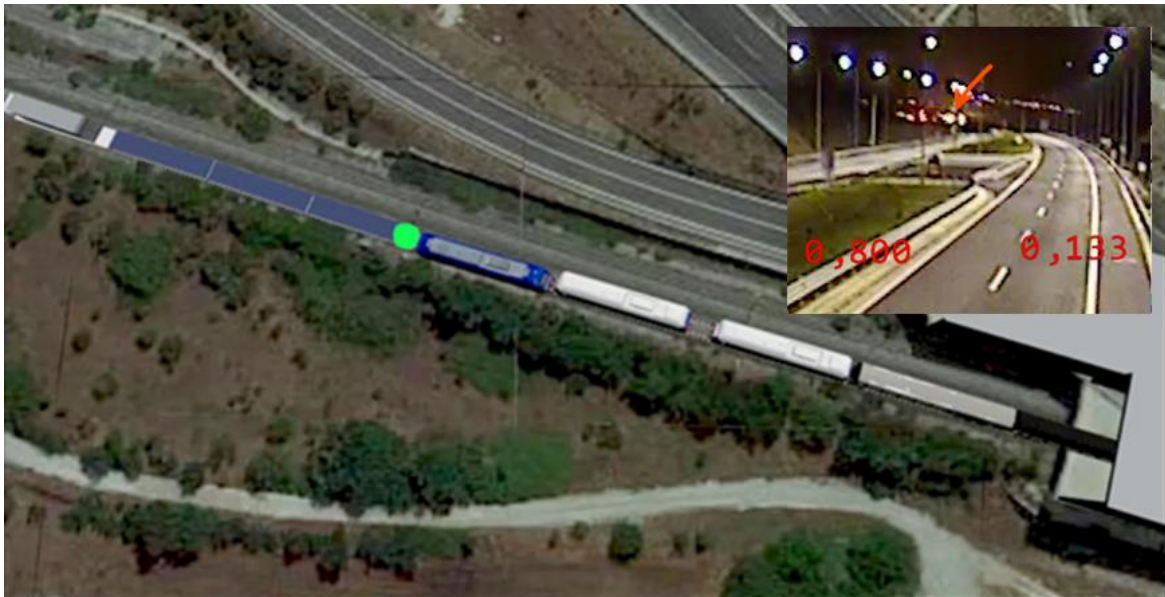
- 134 The second collision is another heavy head-on collision that takes place between the Restaurant Car (i.e. the 3rd vehicle) of train IC-62 and an area between the rear end of the locomotive 120-012 and the first of the wagons carrying steel plates (Figure 18). The effort to locate and examine all the remains of the corresponding vehicles of the freight train, shows that it is not possible to locate and identify all these parts.

Figure 18. Estimated area for second collision for the freight train (simulated image behind still of video footage).

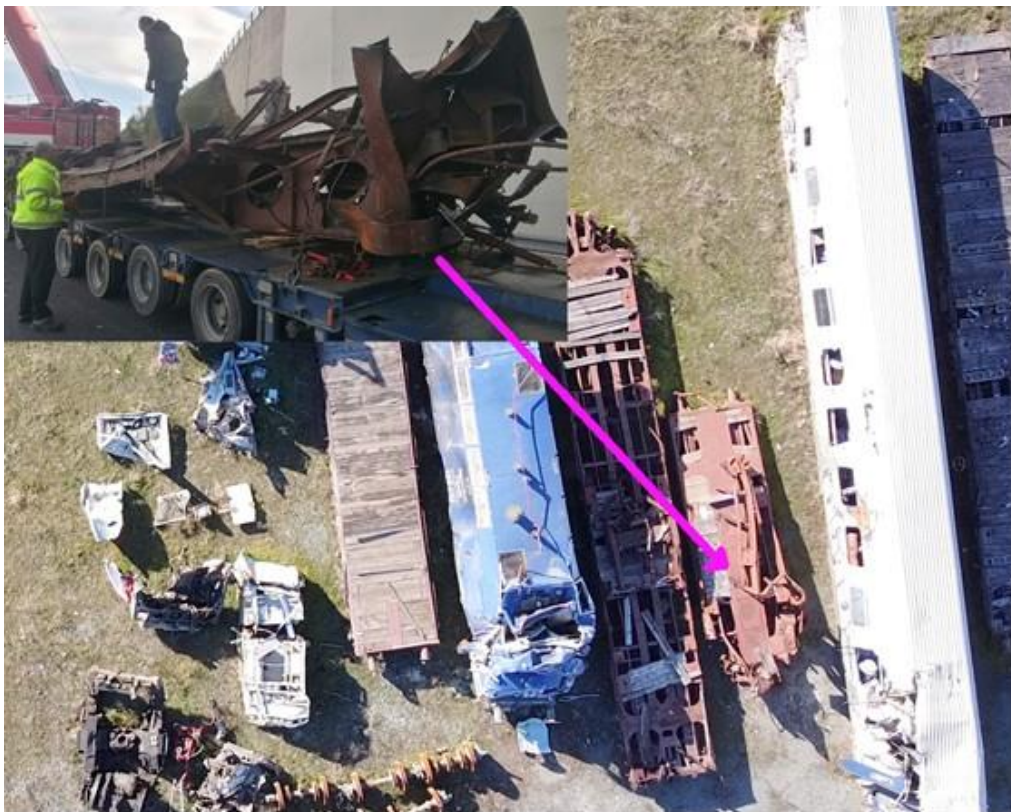
- 135 The rear part of the first platform wagon can be identified among the remains of the vehicles at Koulouri, but the front part is not available for examination, as it was presumably cut in smaller pieces in order to allow easy transport (Figure 19). This action was not documented in any way and there are no photographs of the carriage in its original condition at the crash site before being cut up and moved by an unknown party.

Figure 19. Remains of the first platform that was carrying steel plates.

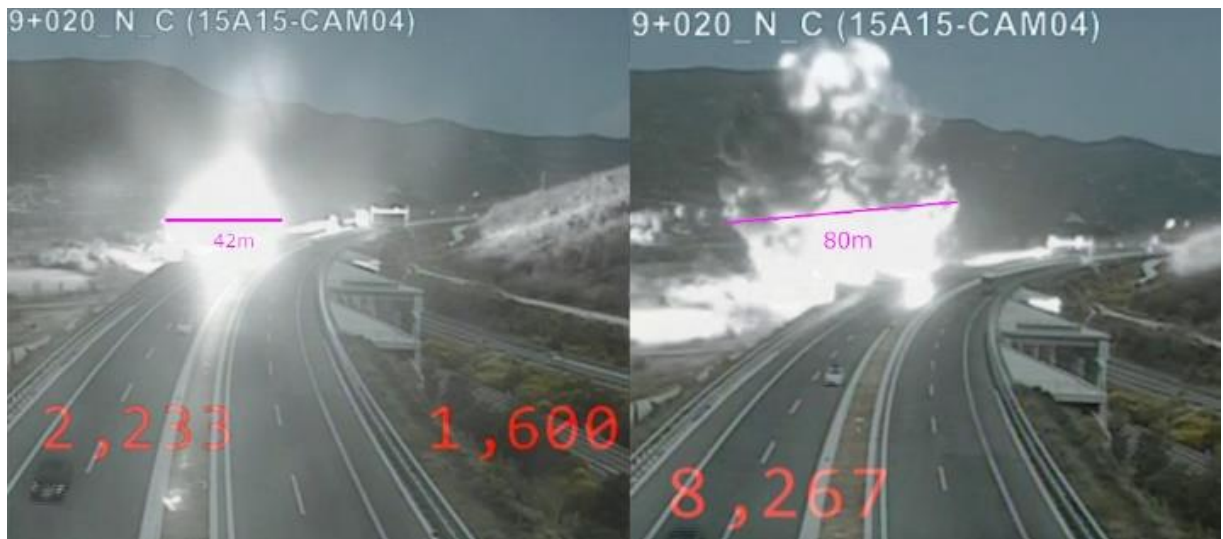
- 147 At the same time, the catenary lines themselves (both lines, one for each direction of travel) have been ripped off due to the collision, but the power was already cut within 0.2-0.3 seconds of the short circuit. Approximately 0.3 seconds after the end of the arc flashes, a fireball starts forming from the ground level and very rapidly expands upwards to a size of approximately 42 meters in diameter, which burns for approximately 2 seconds.
- 148 At approximately 2 seconds after the initial ignition, a second stage starts, when a new fire plume can be observed, moving northbound, away from the 1st stage fireball. This new fire plume is feeding the original fireball until it grows to almost double the size (80 meters) at approximately 4 seconds after ignition (Figure 28, Figure 29, Figure 30).

Figure 28. First (left) and second stage (right) of the fireball.

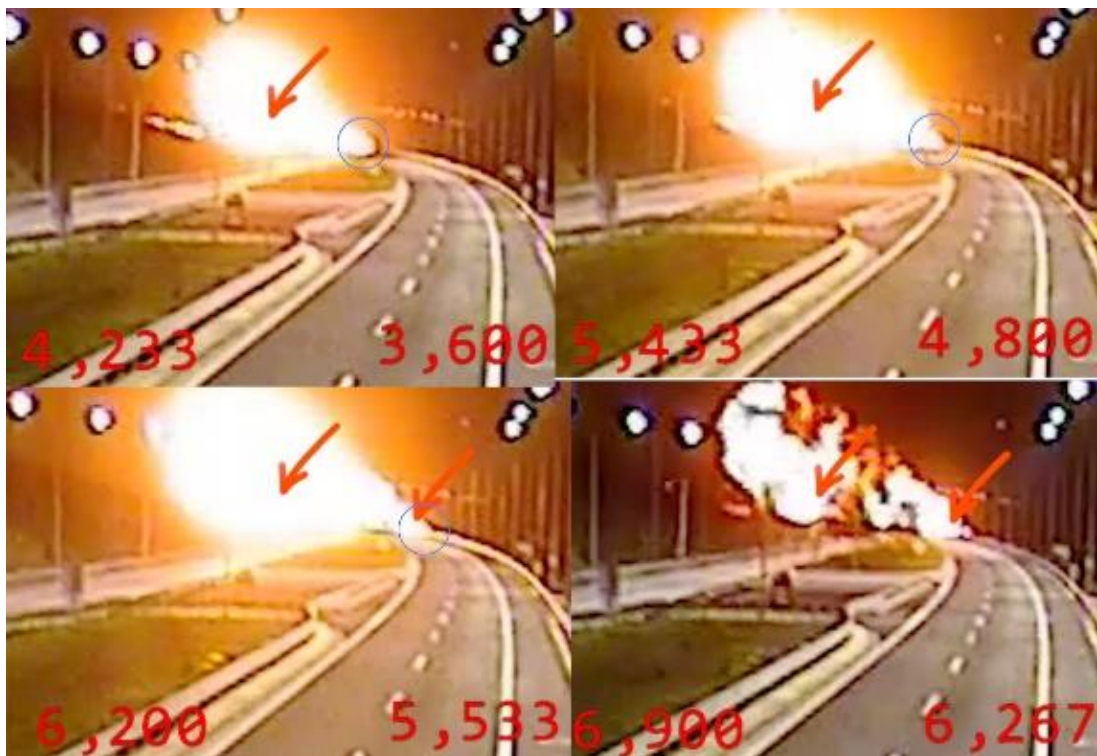
Figure 29. Second stage, fireball (left side of pictures) and fire plume (right side of the pictures)

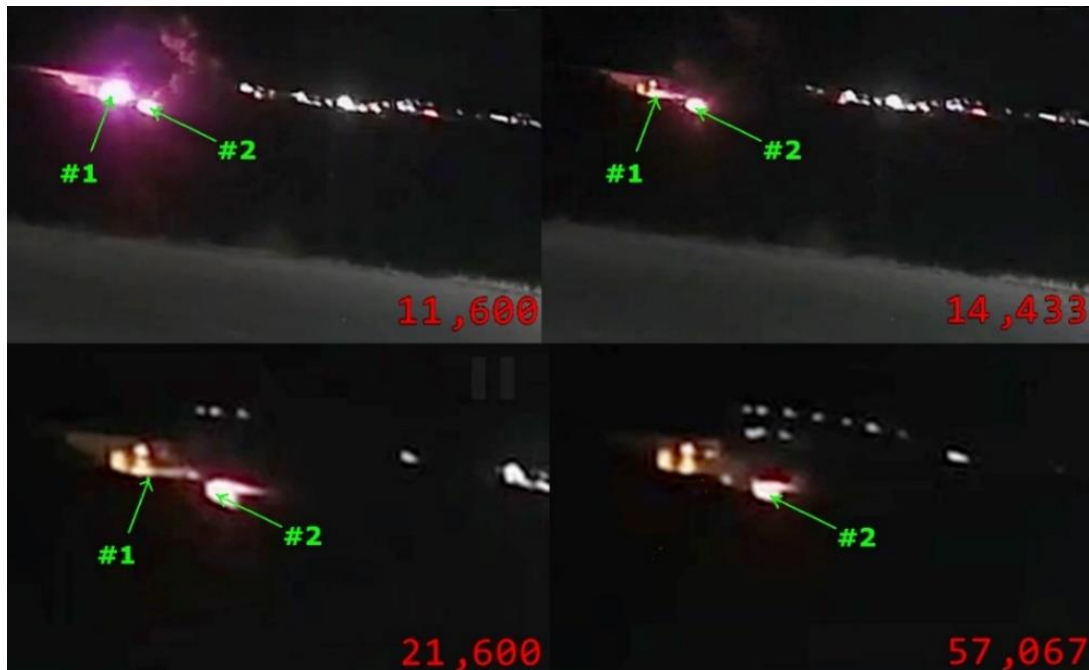
Figure 31. Pool fires #1 and #2

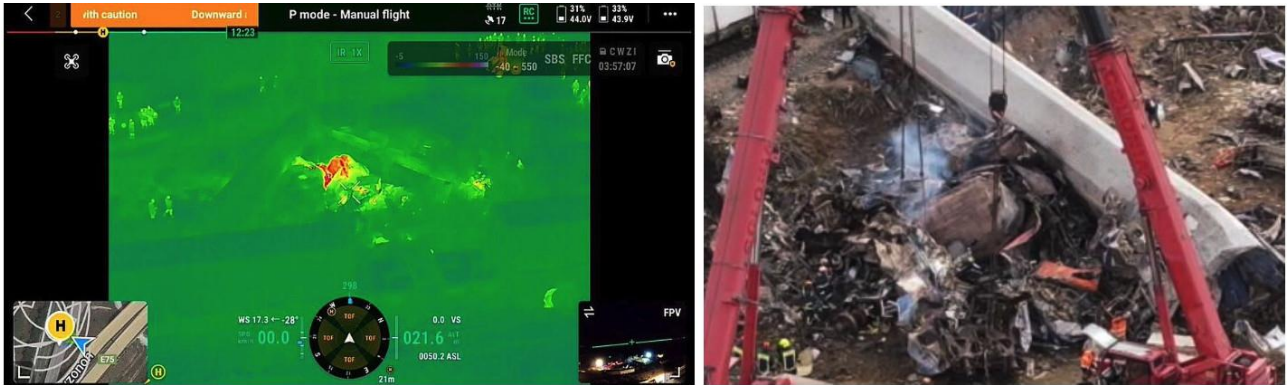
Figure 32. Fire simmering inside the Restaurant Car for 12 hours.

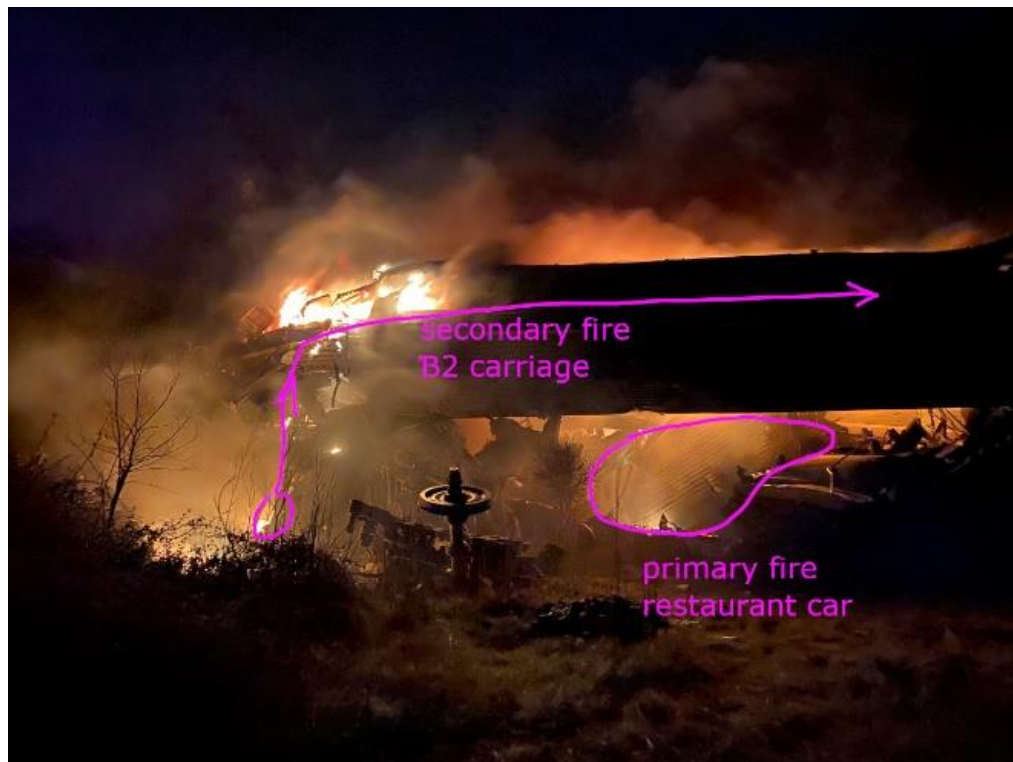
Figure 33. Another fire started at the front of the B2 coach.

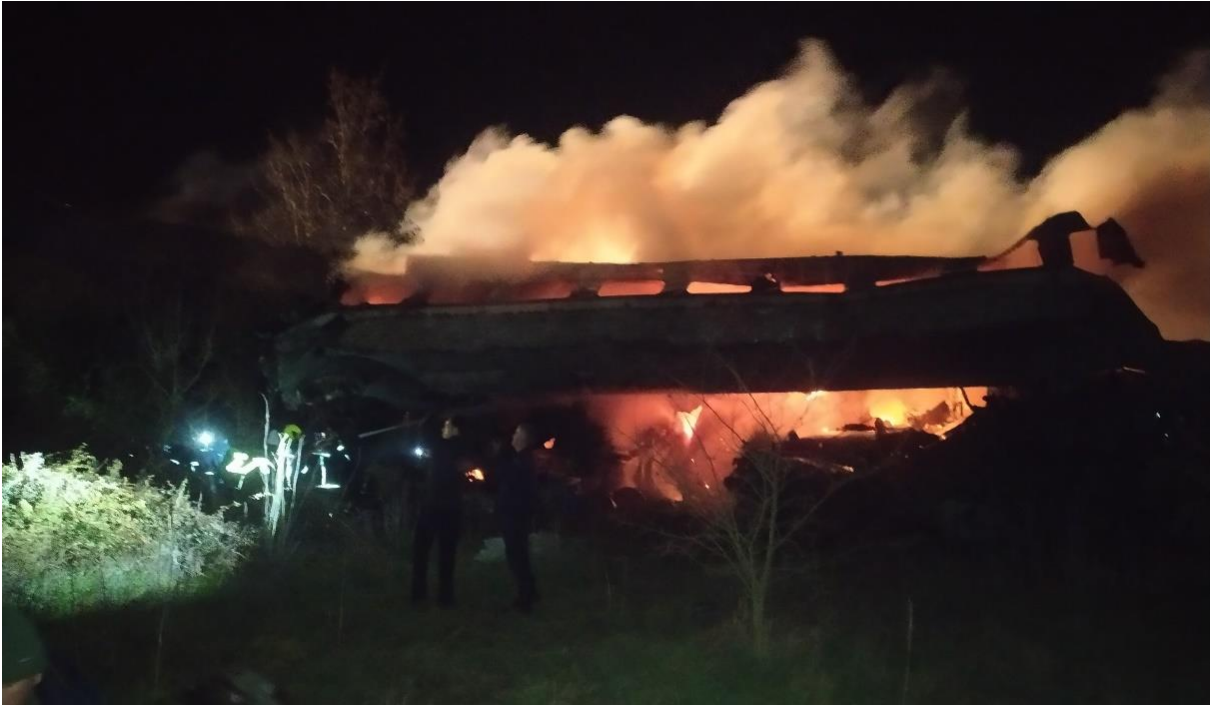
Figure 34. Photo showing the heavy fires in the Restaurant Car area (behind), and on the B2 coach (front, above) (Source: EDAPO).

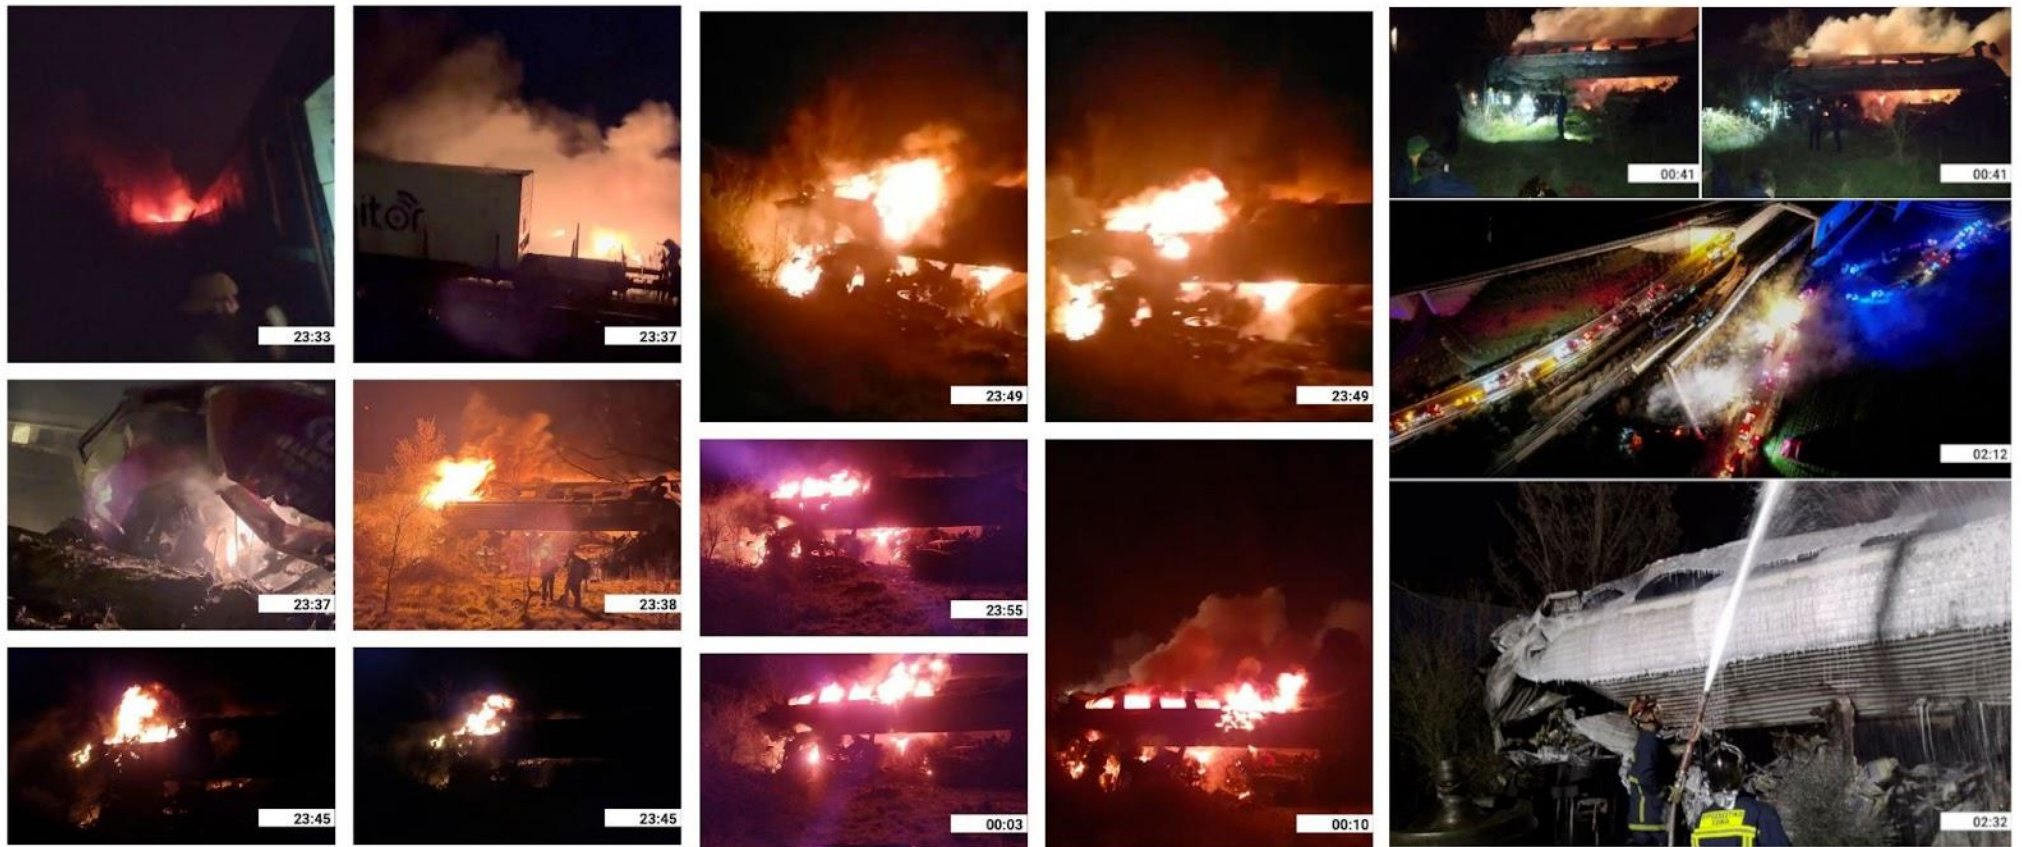
Figure 35. Photos of the fires development and their timestamp (source: EDAPO).

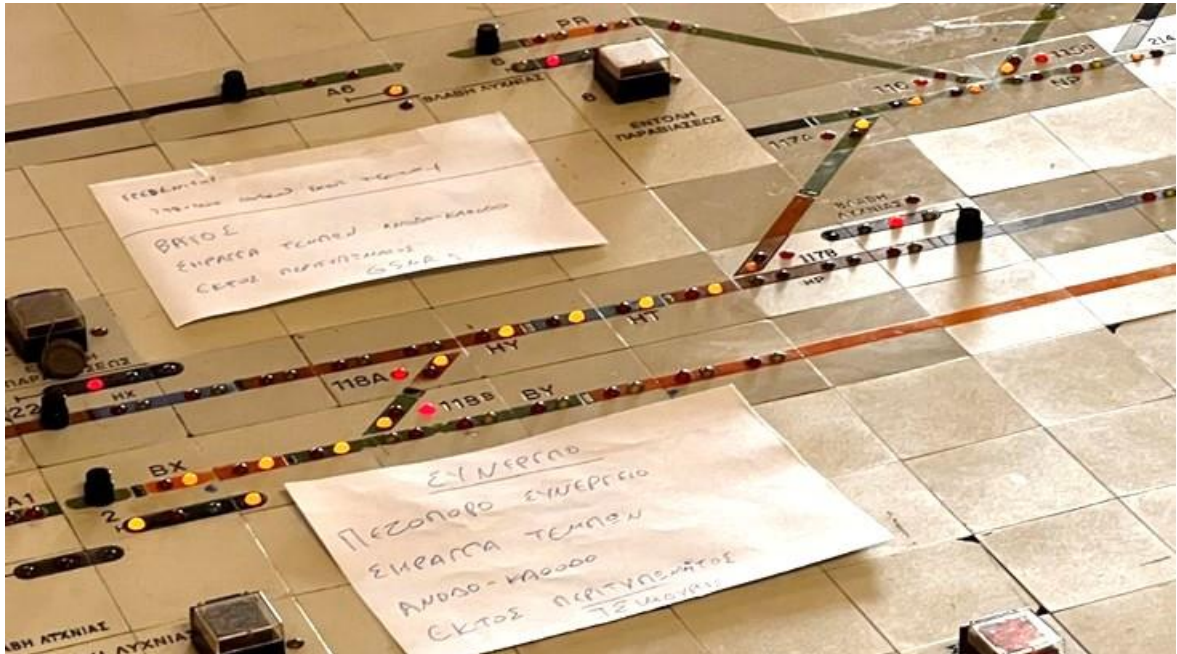
Figure 48. Detail of the Larissa Control Panel with a route set to cross a switch in a bypass position.

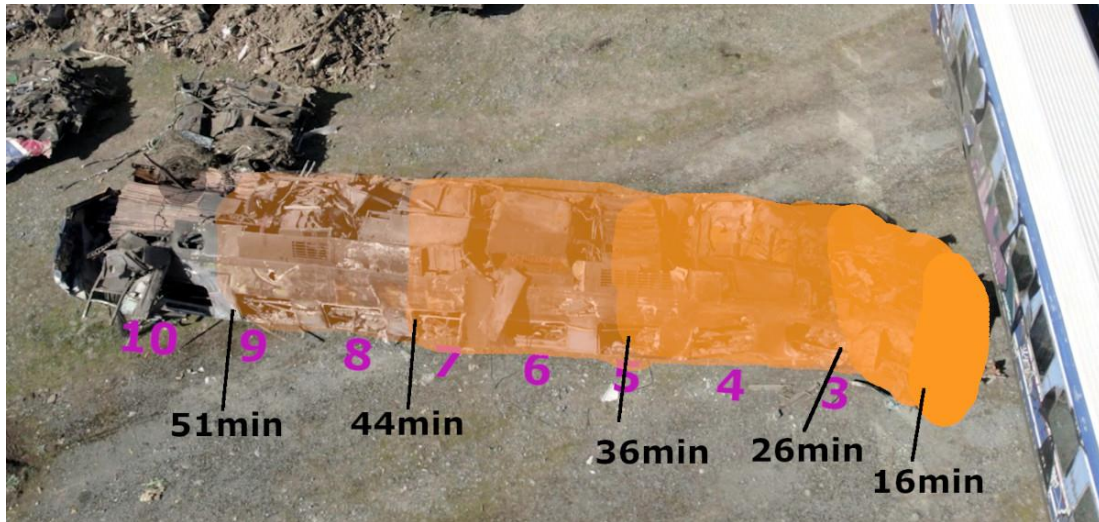
Figure 57. Progression of the fire in the B2 coach (from right to left, in minutes). (Source: EDAPO)

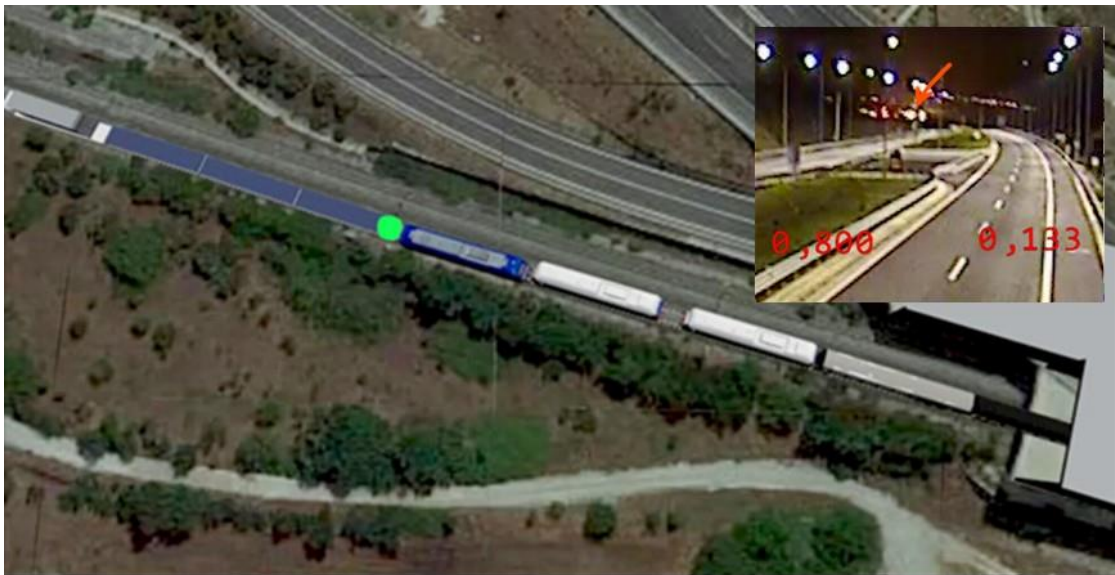
Figure 58. Estimated point of initial ignition.

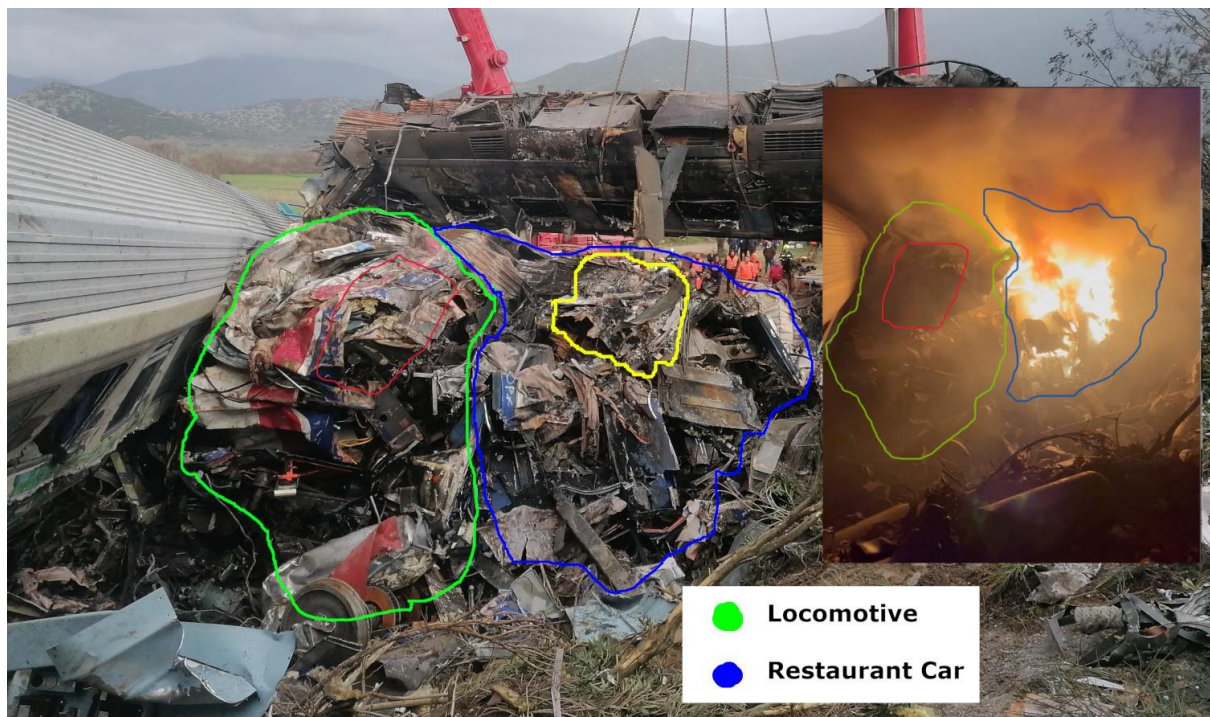
Figure 60. Restaurant burning next to the passenger train locomotive, with the position of the transformer in red.

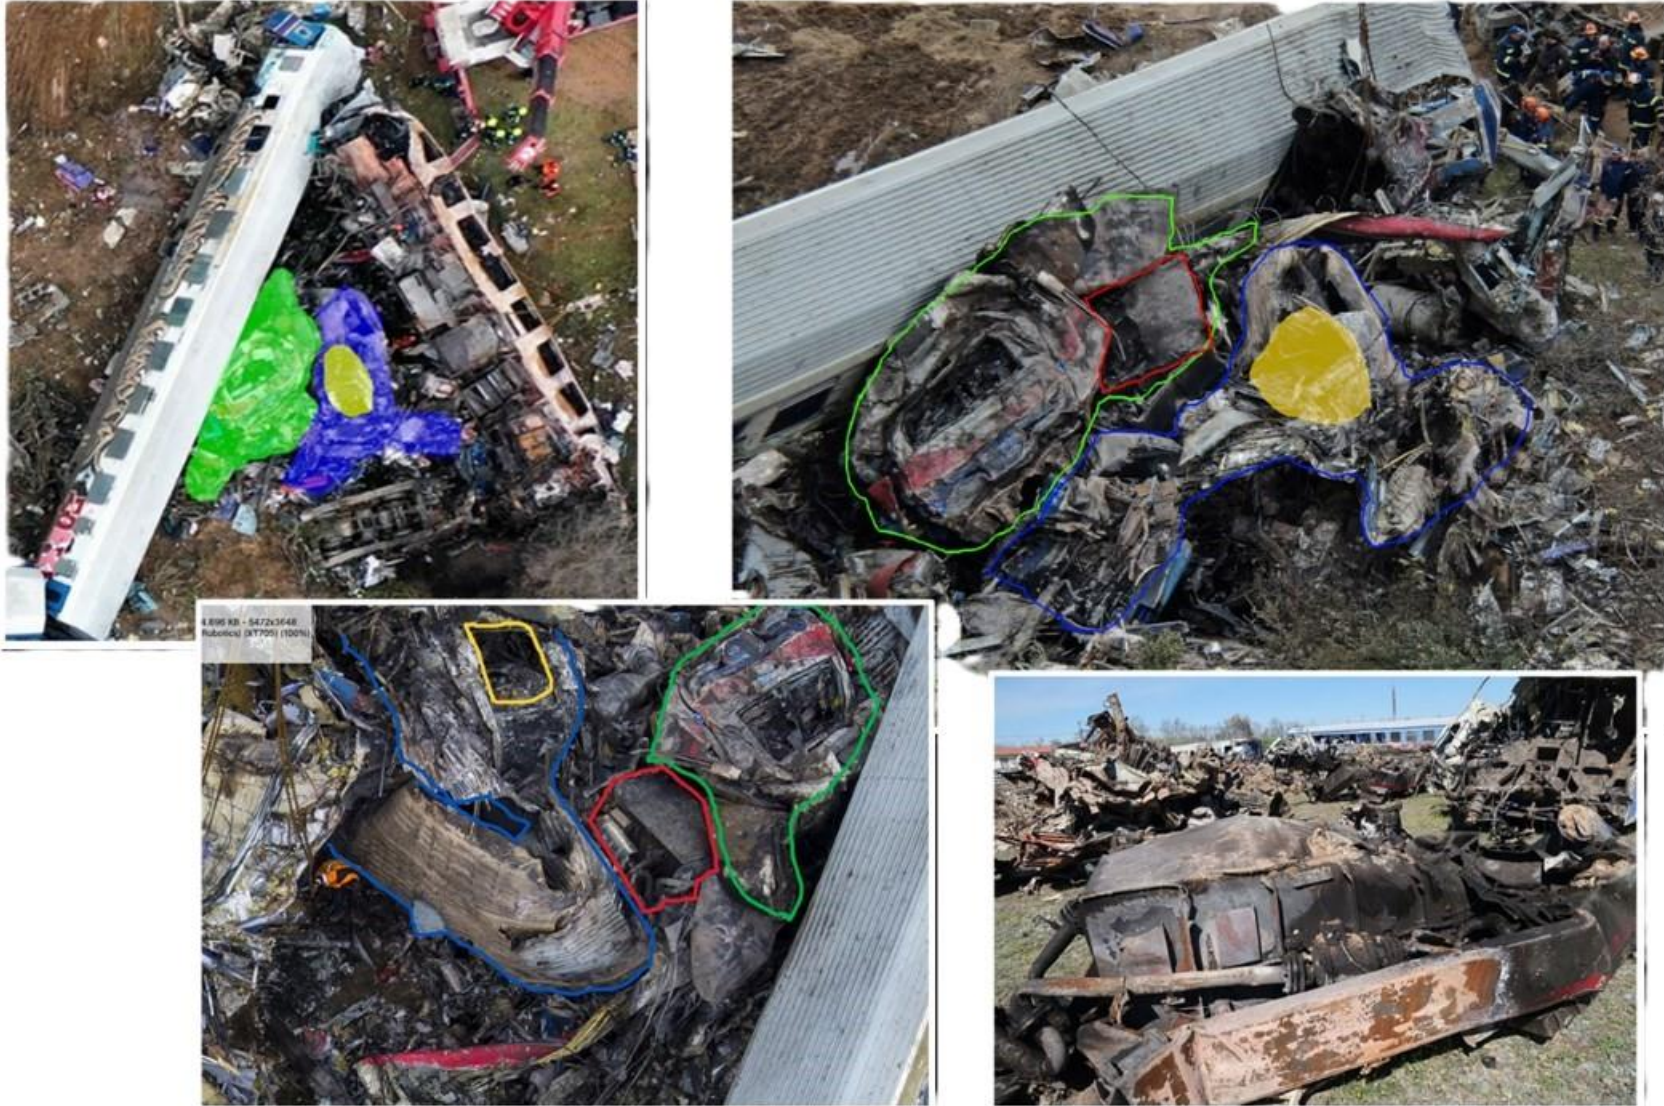
Figure 61. Further images of the location of the Restaurant Car, Passenger Locomotive and its transformer.

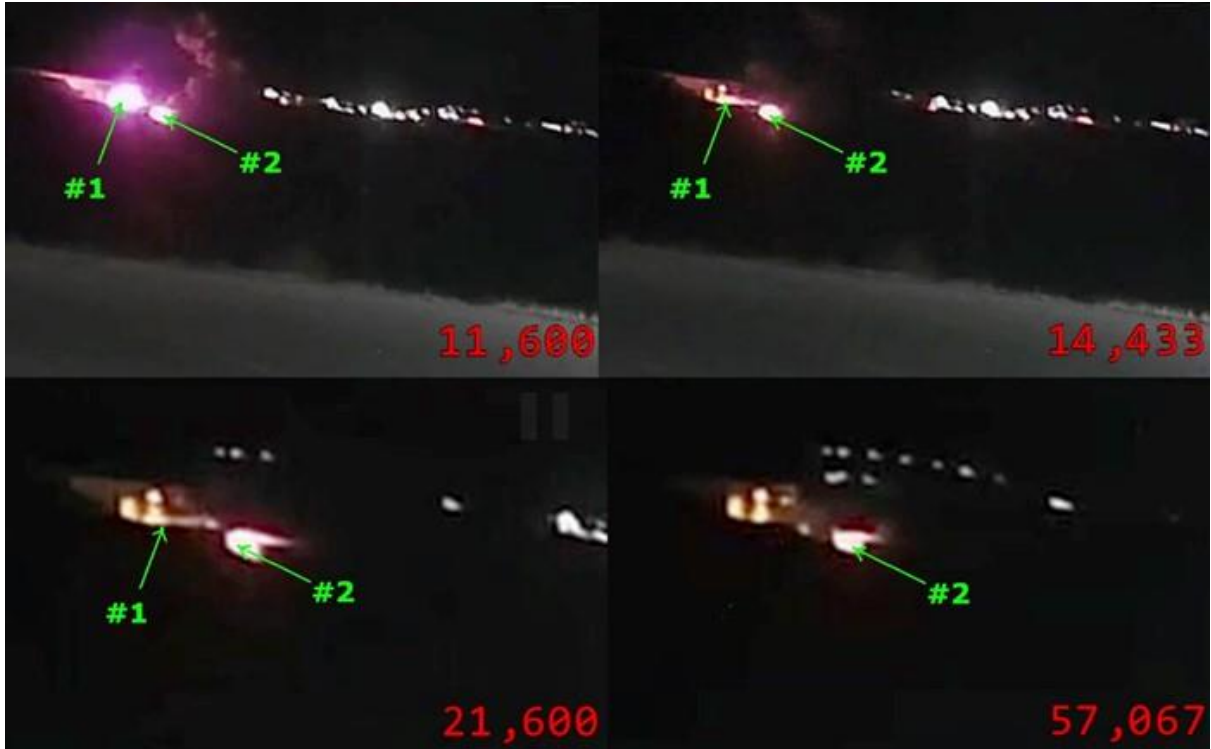
Figure 62. Fire plume moving into pool fire #2, as observed by the "Maliakos-Kleidi" camera.

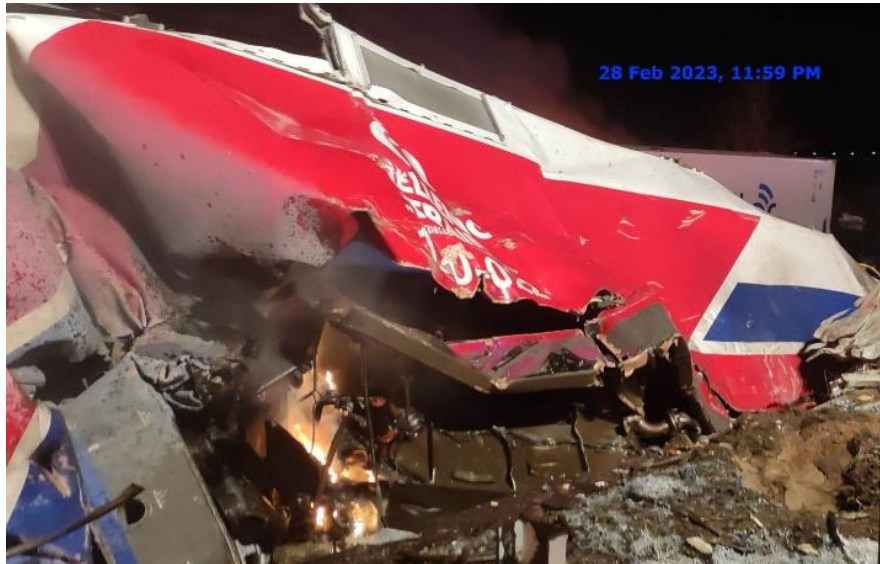
Figure 65. A local fire inside and outside the broken transformer of the first locomotive of the freight train, 40 minutes after the accident.

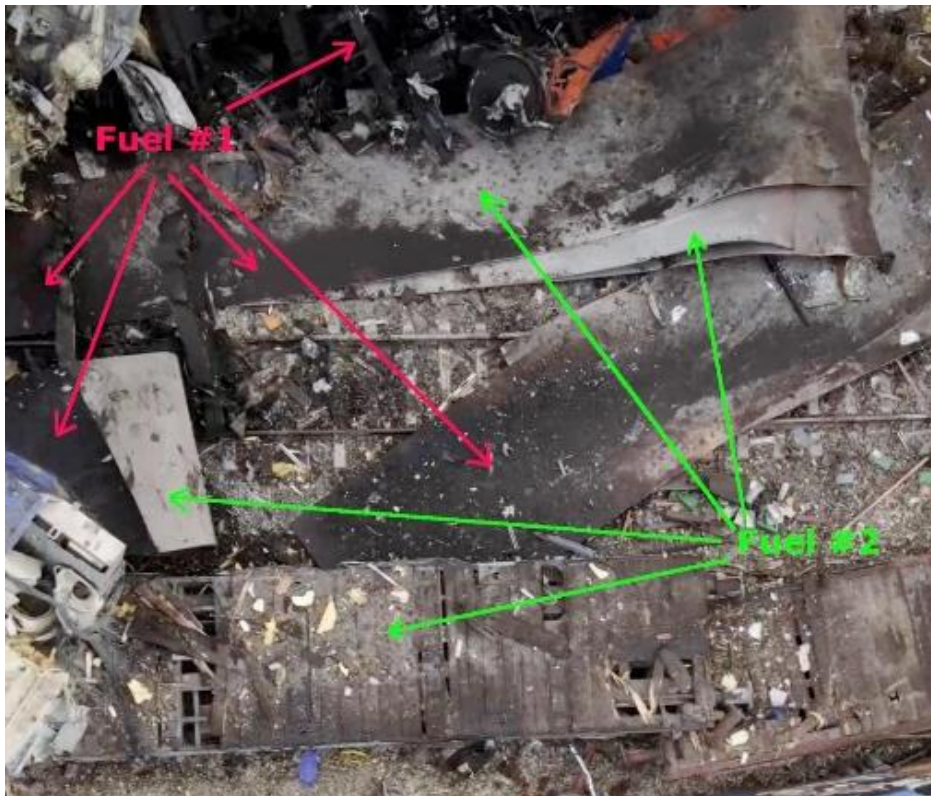
Figure 66. Evidence of two different fuels burning in the pool fire #1, one leaving black, the other leaving white residue.

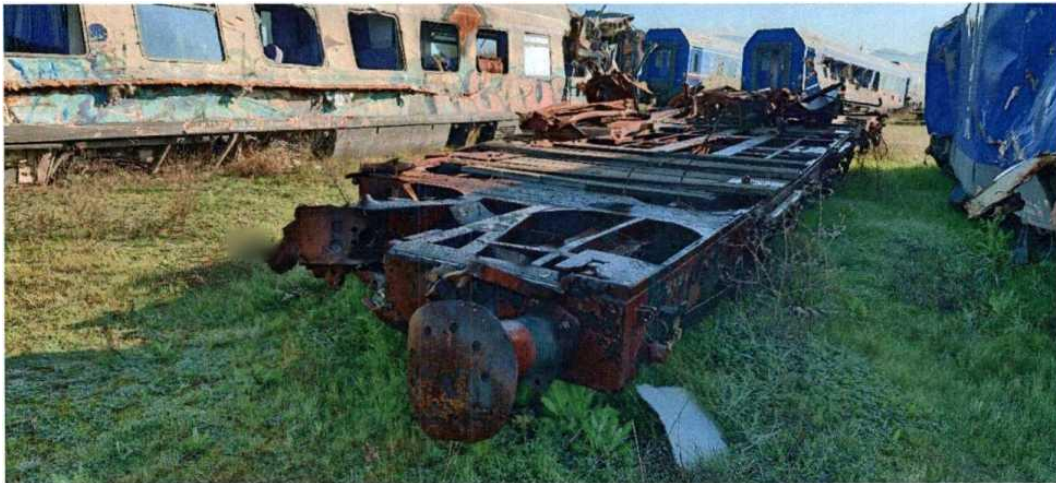
Figure 79. Position 3) nr 1 platform carrying steel plates, front half totally destroyed by heavy impact with Restaurant Car.

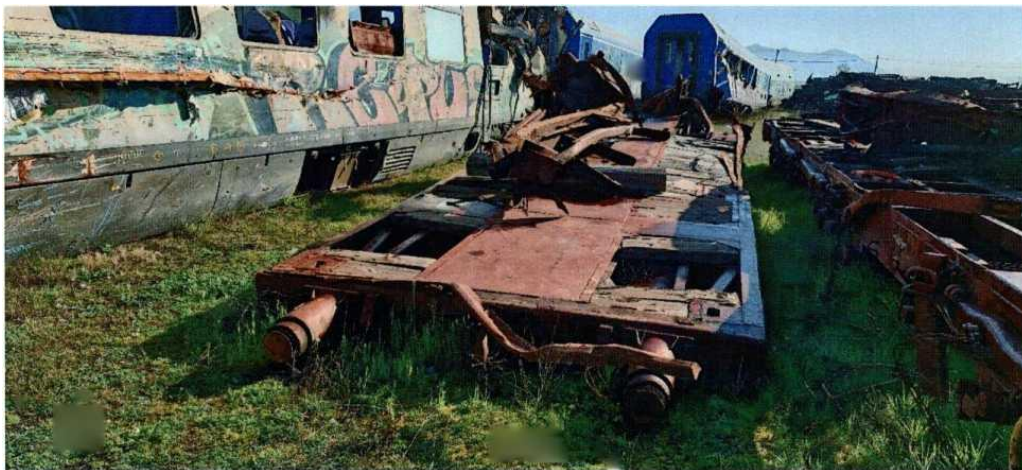
Figure 80. Position 4) nr 2 platform carrying steel plates, lost bogies from derailment but very slightly damaged, no signs of heavy crash.

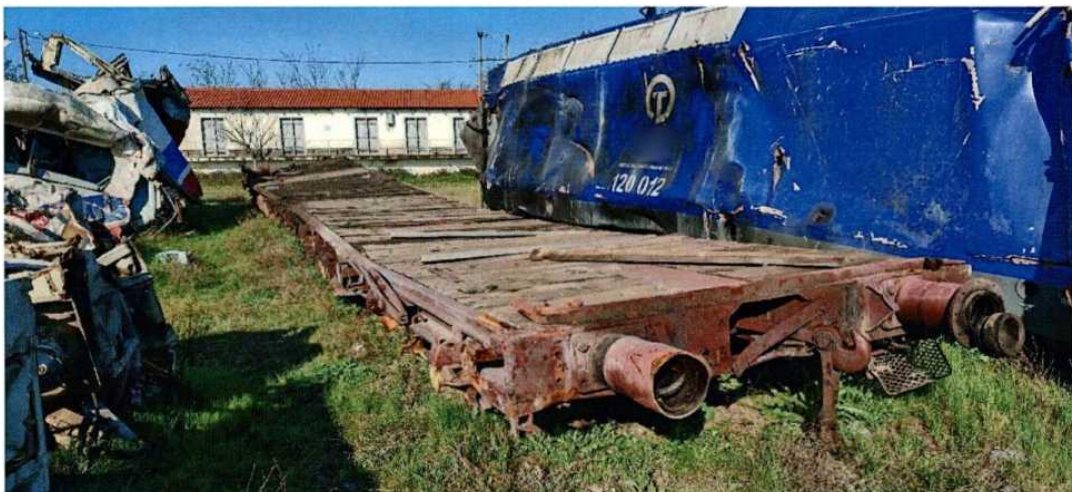
Figure 81. Position 5) nr 3 platform carrying steel plates, lost bogies from derailment, slight damage (twist) due to crash from the rear.

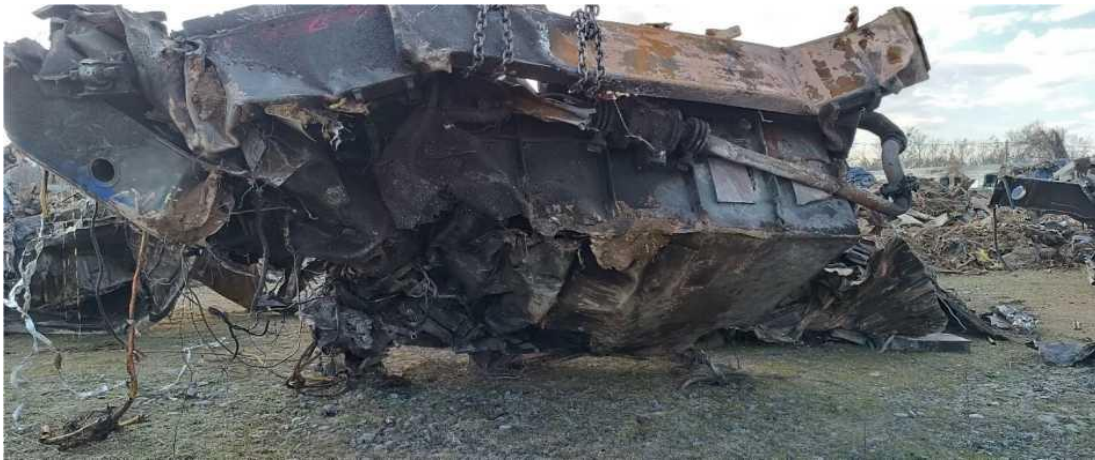
Figure 85. Position 1) 120 023 locomotive, totally destroyed, broken into large pieces. Remaining piece of the basement platform. Part with transformer still visible. Other side in Figure 17. At the position 2) the A1 1st class coach, totally destroyed, has broken into small pieces, and was not recognisable as a whole vehicle.

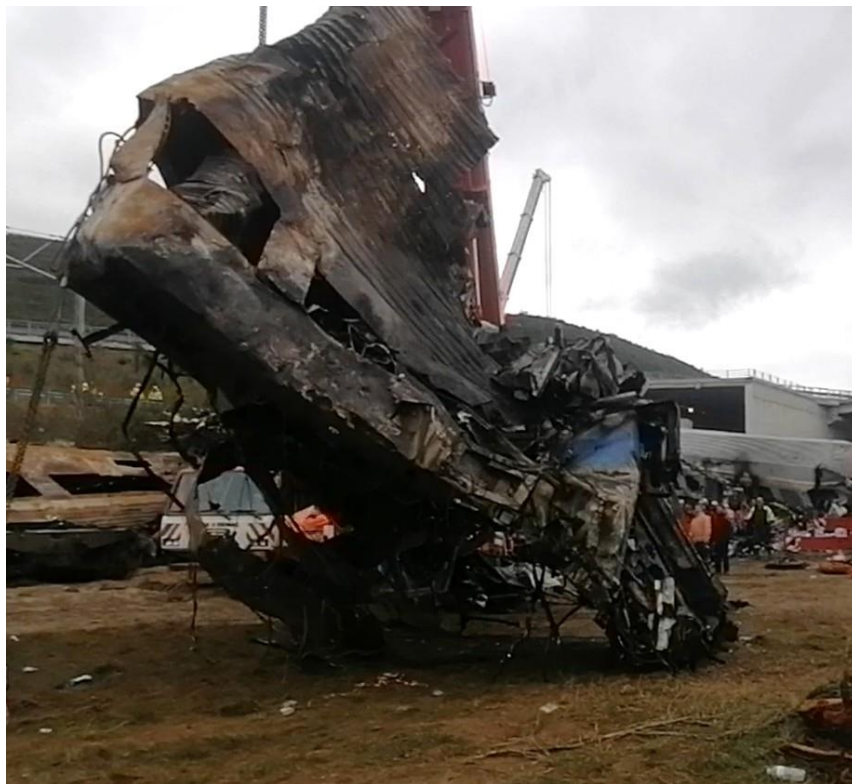
Figure 86. Position 3) Restaurant Car, very heavily damaged from initial crash (folded, bent into S-shape) and burned down. Here, suspended from the crane cables.
