Rail Accident Report

Head-on collision between a passenger train and a freight train
in Tempi, 28 February 2023

RL01-2025, 27 February 2025

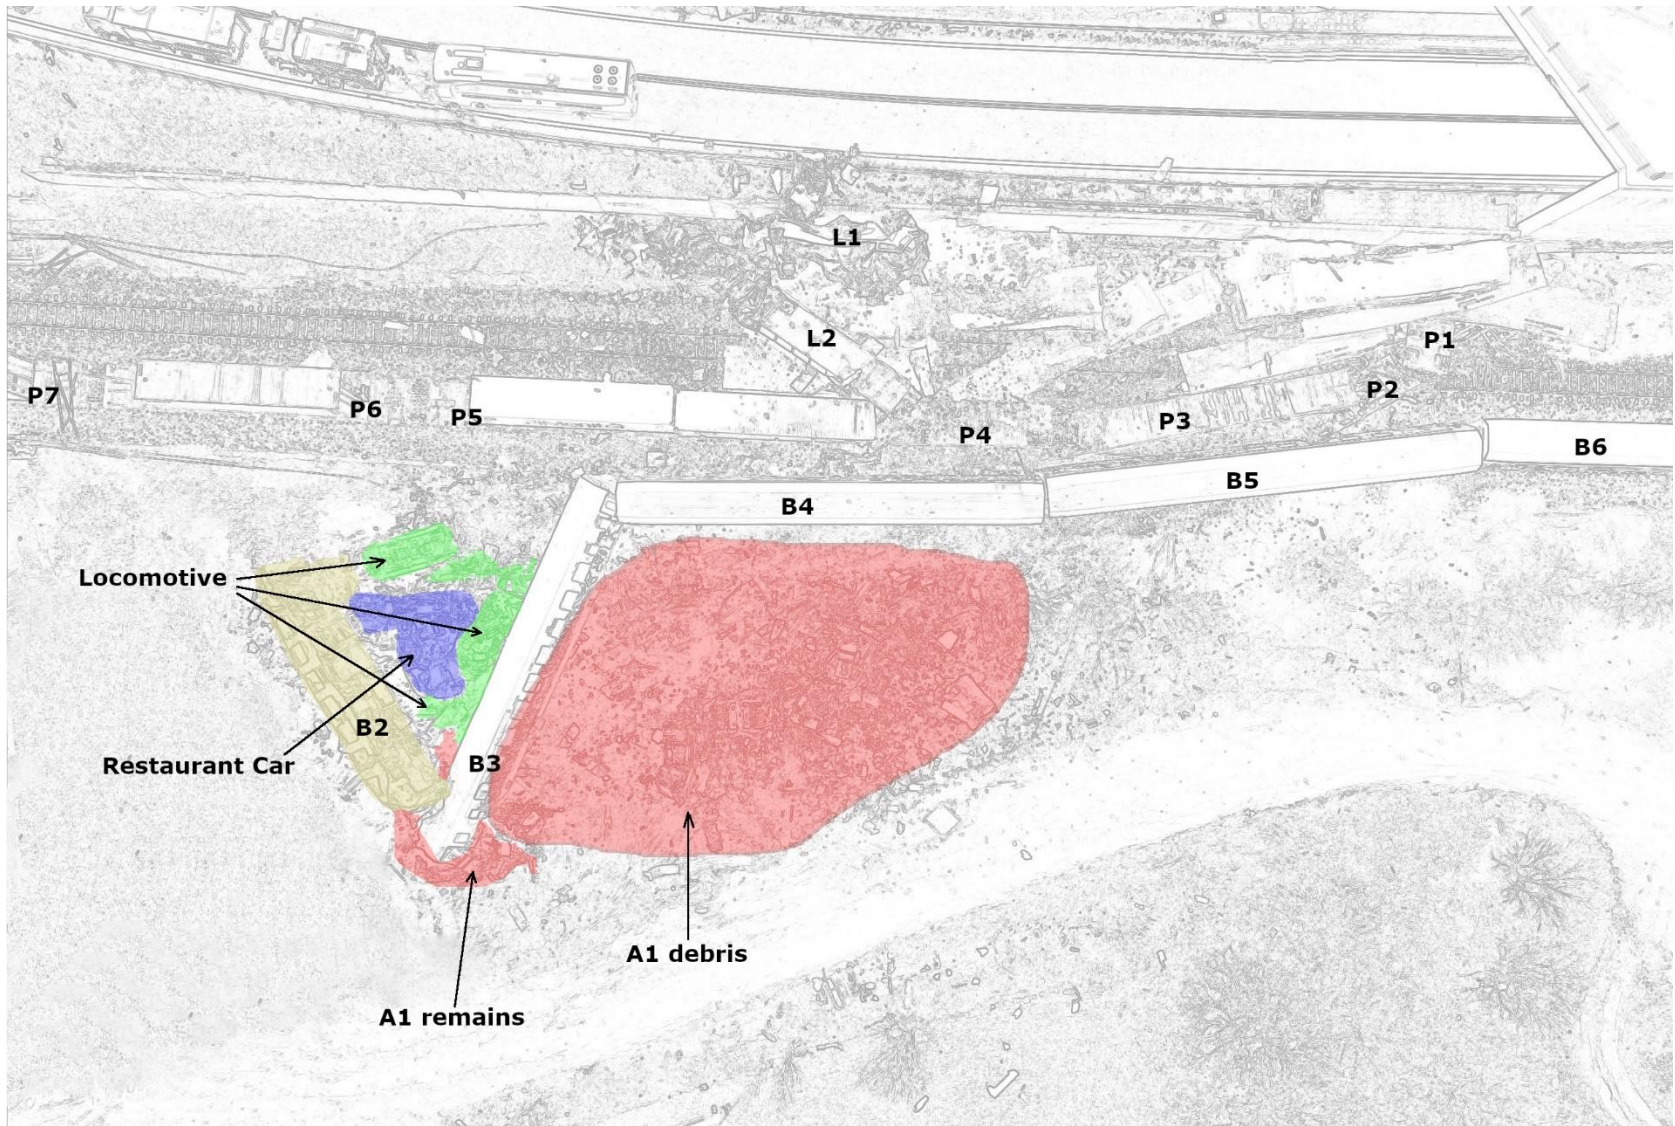
Figure 12. The accident site.

Best estimated point of the 1st collision: X, Freight locomotive 120-022: L1, and 120-012: L2, Passenger train locomotive 120-023: Locomotive areas, First-class A1 coach: A1 areas, Restaurant Car area, Second-class B2 on B3 head, then B3, B4, B5, B6, (B7 under the tunnel), Freight train platforms P 1-2-3-4, and freight wagons 4-7 (and other 6 not on the figure).

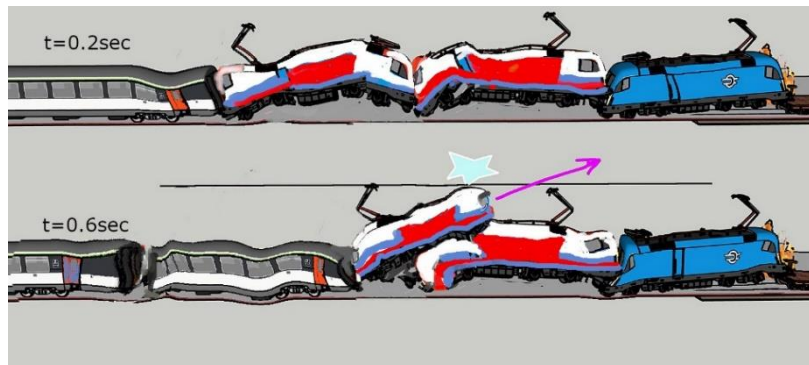
- 131 From the examination of the remains of the first freight train locomotive 120-022, it is clear that the head-on collision bent the front bumper downwards and inwards (Figure 14, Figure 15), severely bending the heavy beams of the lower frame of the locomotive, while at the same time the fact that the roof is missing (Figure 16), is an indication that the passenger train locomotive 120-023 passed over and through the roof of the this 120-022 locomotive.

Figure 15. Movement of the passenger train locomotive 120-023 over and through the roof of the freight train locomotive 120-022.

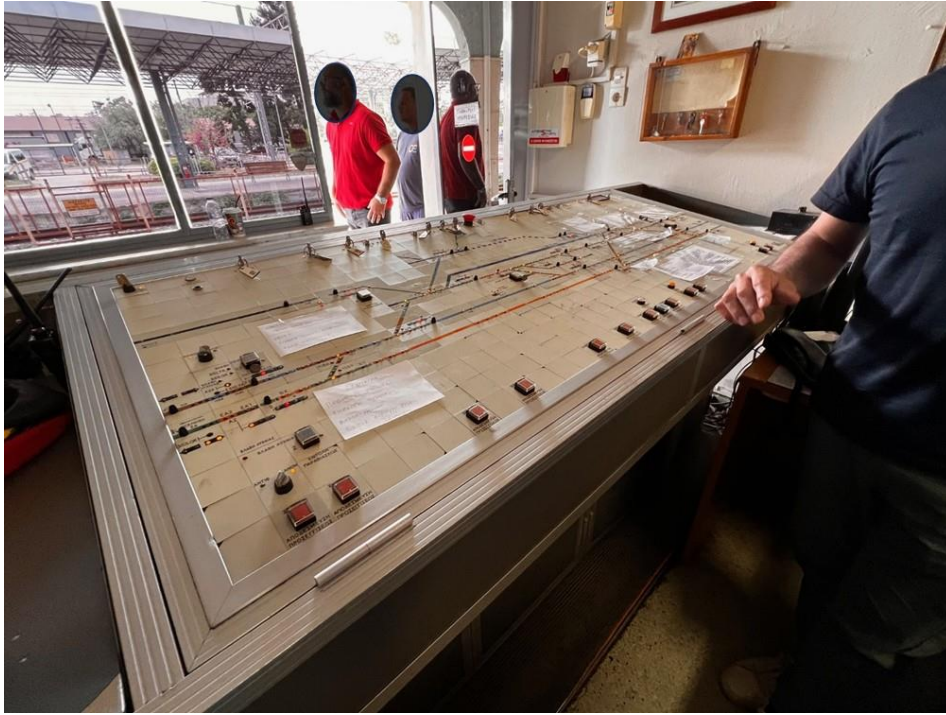
Figure 37. The control panel at Larissa Station

- 189 As it can be observed on the global photo of the control panel (Figure 37), it is a large area with many information and commands that cannot be considered at a glance. To pass from one mode to the other (manual mode to or from automated mode), the station masters must turn a numbered key (the number refers the number of the switch) on the top of the control panel (Figure 46), separately for each switch. The area where to read the switches numbers is small and partially hidden by the plastic and metal key rings (this point is further analysed in the chapter 4.2.2). In the actual practice of using these keys, as it has been explained and shown on site, at least two ways of manipulating them co-exist, one of them being indicative of lack of trust in the system and/or lack of experience (4.2.1.3).

- 243 The indications on the position of switched 118 are small indications, on two distinct positions, on a larger Control Panel (the information of the Figure 47 among the ones from the whole Figure 37).

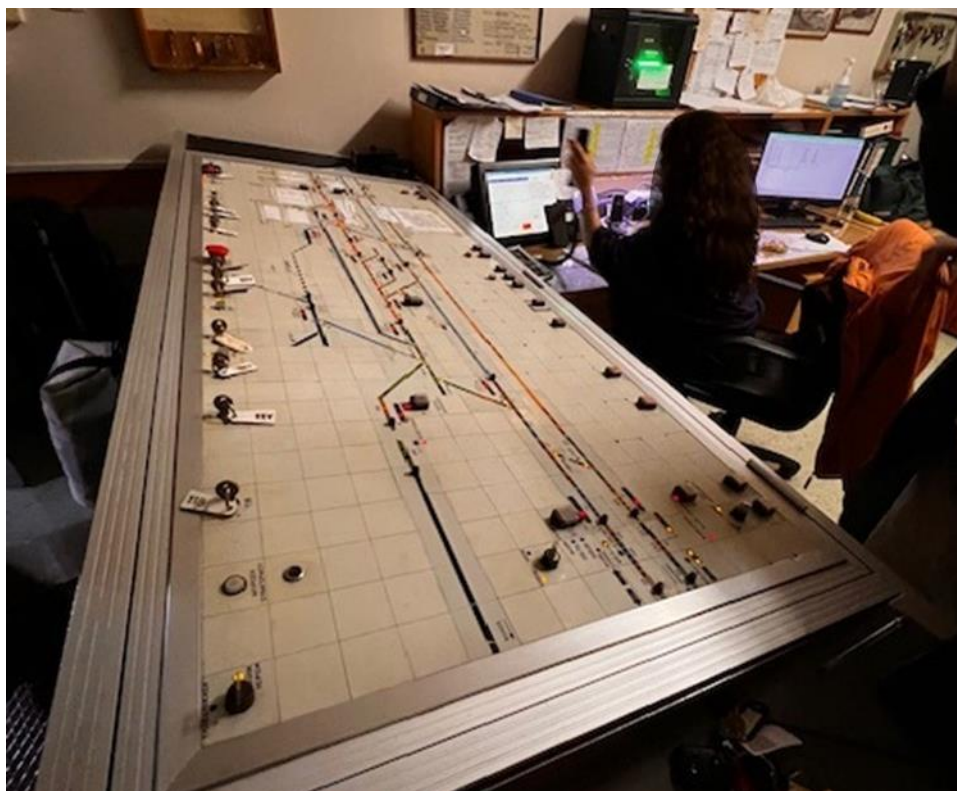
192 Taken together with another source of influence, namely the numerous communications (as analysed in point 4.2.1.8), in the period of time just before and while the control panel was showing the passage of train IC-62 (240), it should be noted that this panel and the communications area are organised and physically positioned in a way that makes it very difficult to perform both tasks at the same moment. In morning and afternoon shifts these tasks are performed by two station masters in order to avoid excessive workload. When you are concentrating on communications, you are turned sideways in relation to the control panel and the LEDs that are lit in this case are behind you (Figure 41. Positions of station masters when facing the control panel (above) and when

193). This directly, logically and naturally explains how Larissa's station master did not 'see' or 'look', and therefore did not 'detect' the train's passage towards the descending track (4.2.2). During the investigation, 2 other situations were identified by the investigation team: one in which the station masters had adapted it and added a desk just in front of the control panel (Figure 42), and the other one, in Athens, when a Station Manager reported this as an issue and their manager made the situation more adapted.

Figure 41. Positions of station masters when facing the control panel (above) and when communicating (below) in Larissa station.

- 245 Furthermore, the way the communication means (VHF console, GSM-R and telephone) are positioned on the right of the control panel and at a lower level (Figure 41). This means that, when occupied with whatever communication and logically directed towards the used means of communication, the indications related to the position of switches 118 and the departure of train IC-62 were situated behind the left shoulder of the station master in the left bottom corner of the control panel and so in practice invisible (192).

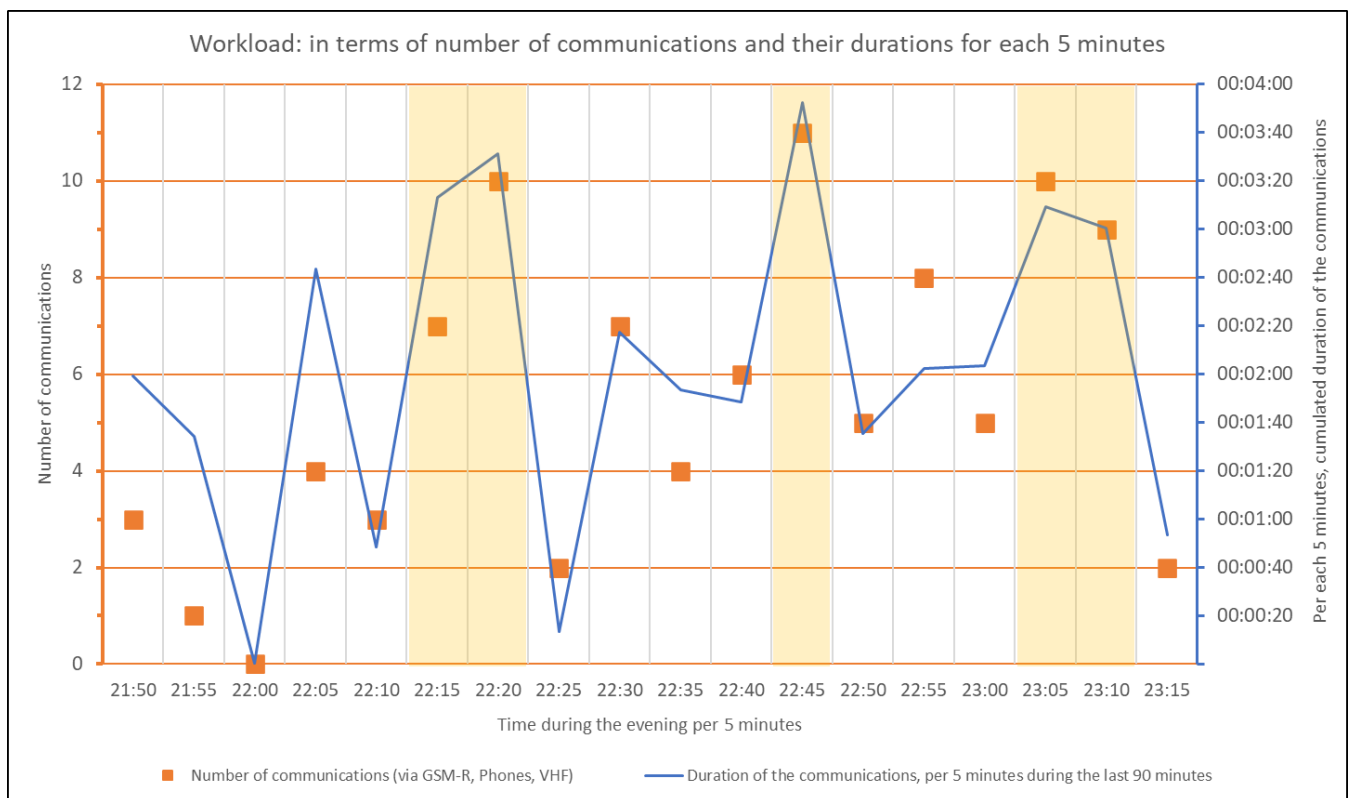
Figure 44. Factual analysis of the communication workload as a risk to be taken into account during HOF integration.

- 219 The variability that resides in the error made by the Larissa station master may have parts of its sources of influence in the amount, the duration and the diversity of the communications he had to treat, process or follow-up, especially during the last hour and even more during the last half an hour. Indeed, considering the number of interlocutors (train drivers, switch operator, level crossing guard and residents, policeman, station staff, traffic regulator and other station masters), the topics, and the duration left to “think” or “write”, several experimented station masters including one of their managers admitted that the workload at this period of time was more than critical. And with such a combination of workload factors being very rare, it can be considered that this situation has been a huge trap for an insufficiently prepared or unexperienced station master.

- 220 Analysis of only the communications, not even taking into account other tasks, indicate three peak periods (Figure 44) that appear to correspond with the consecutive mistakes made by the station master: setting the routes for respectively the train 2597 and IC-62 and not detecting the mistake with switch 118. This indicates that periods of too heavy workload, in particular for less experiences operators, can be a direct cause for errors, mistakes and routine violation, because there is “no-time-to-think” or one is “captured-by-the-flow-of-issues-to-contain”. This type of workload analysis, with results beyond human capabilities, shows the importance of integration human and organisational factors in risk management practices (4.2.80).
